BACK RIVER LIVING SHORELINE MARSH SHORELINE STABILIZATION PROJECT OLD SAYBROOK, CONNECTICUT

March 2023 (revised May 2023)
File No. 01.0175620.00

Re: Back River Living Shoreline
Shoreline Stabilization Design
Old Saybrook, Connecticut 06355

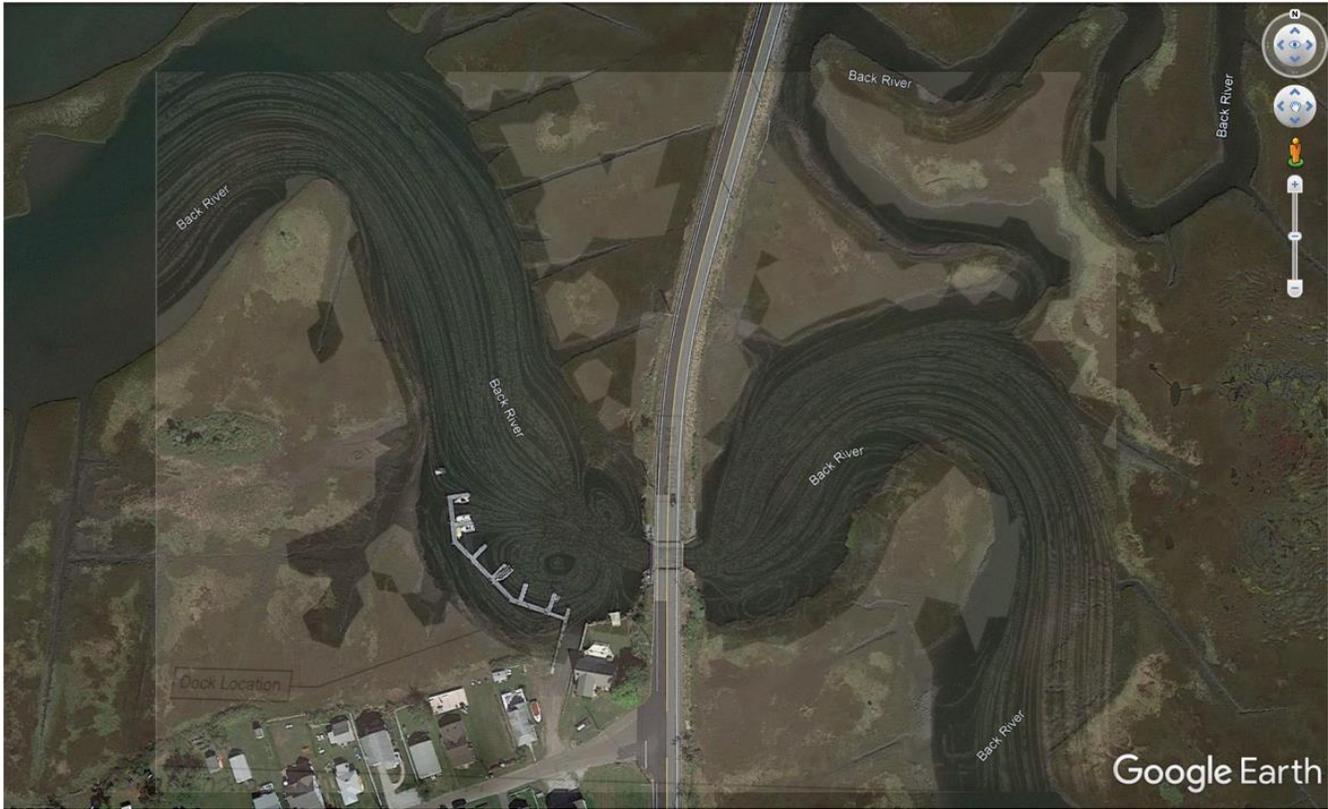
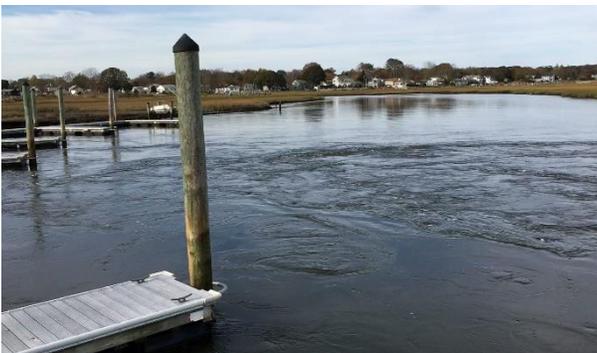
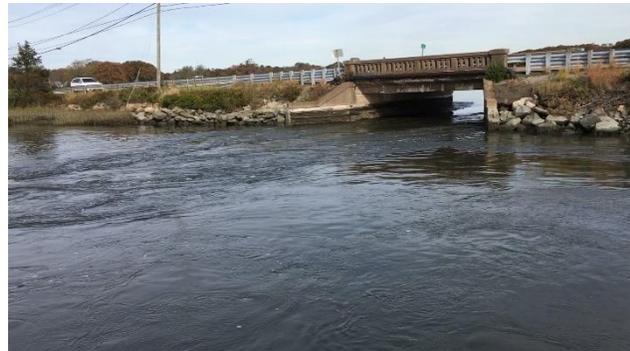
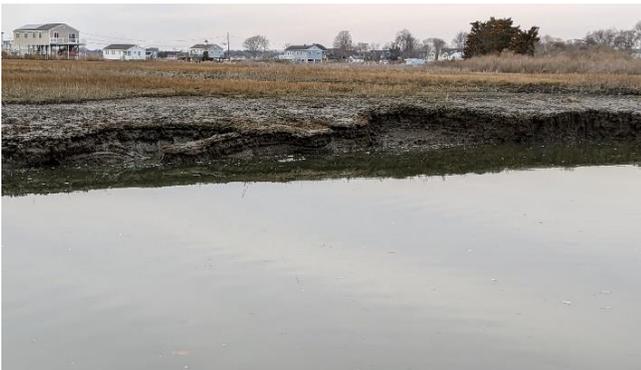
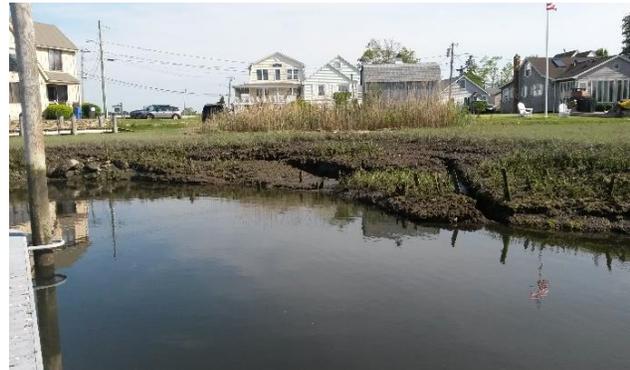
Figure 3: Back River On-Going Adverse Impacts

Modeled Flow Vectors (above); High velocity flow (below left) and whirlpools (below right)

Marsh edge erosion

Figure 2 presents the results of CT ECO SLAMM modeling for the project vicinity. **Figure 3** highlights the adverse conditions resulting from the bridge hydraulics.

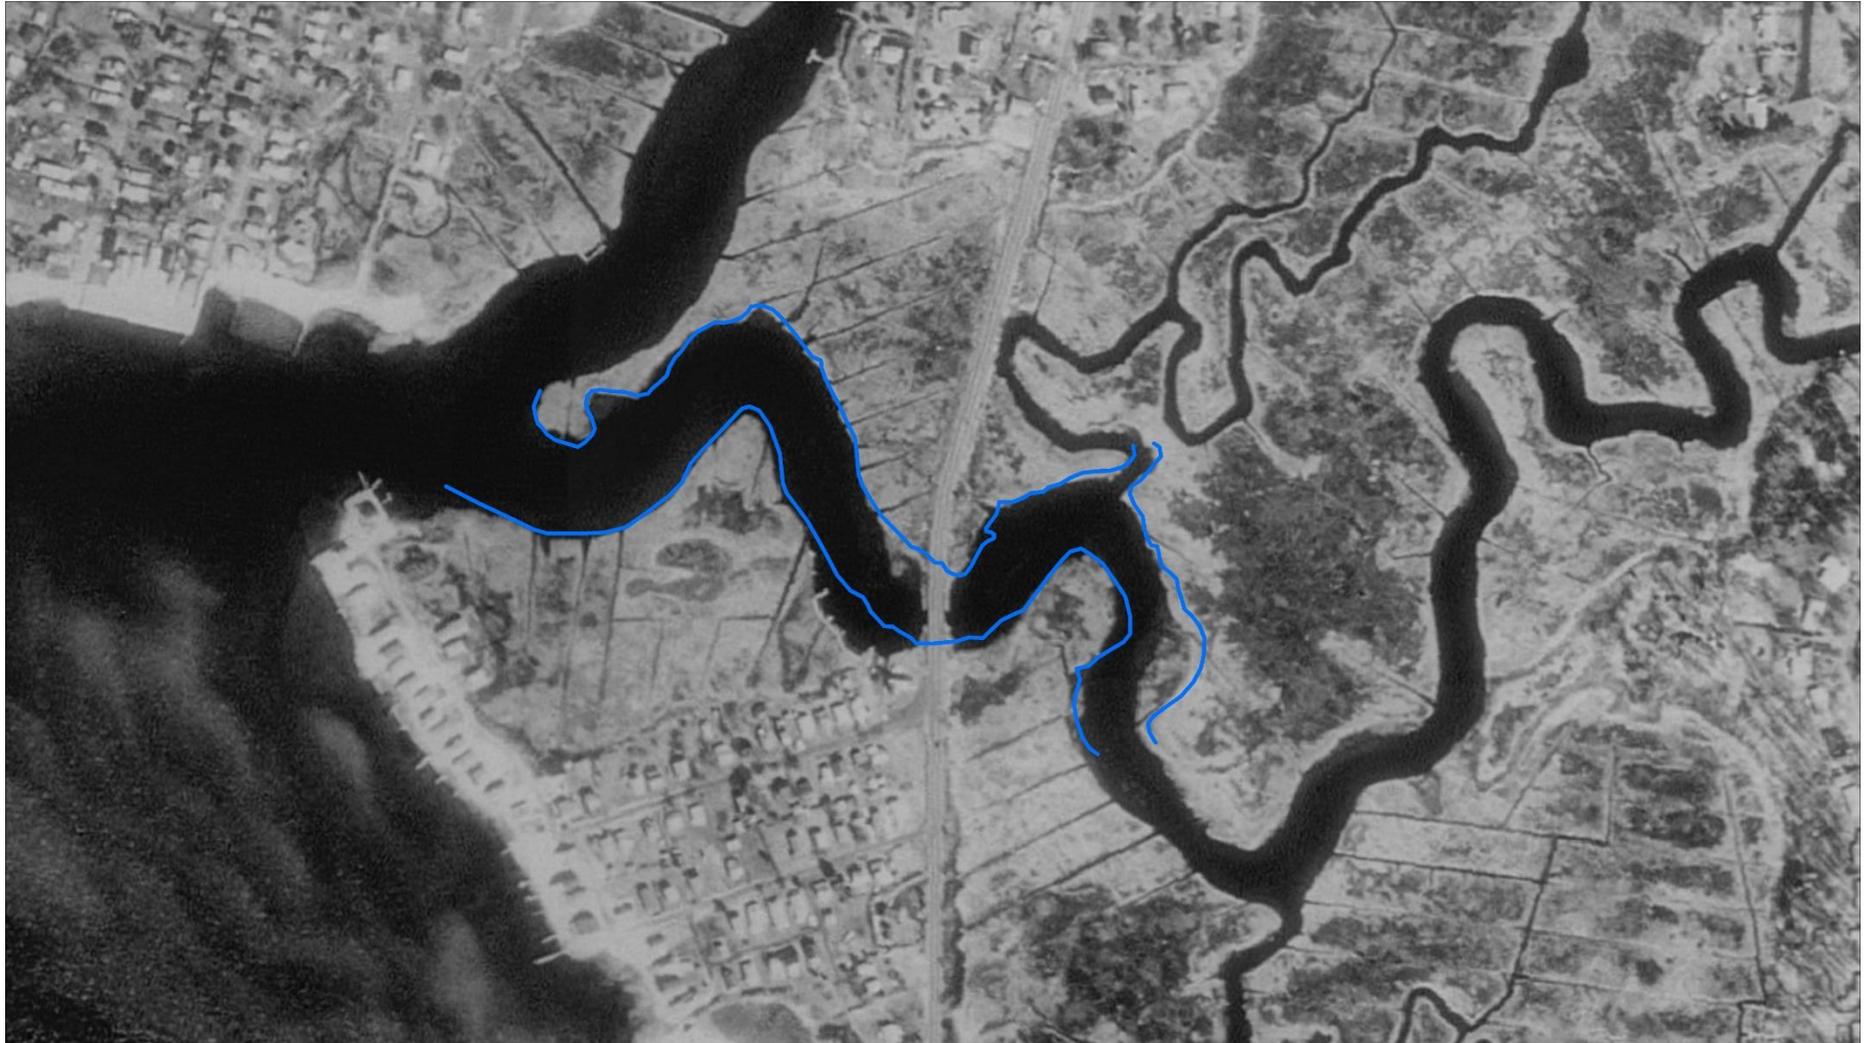
Figure B-5: 1990 Shoreline in Project Vicinity relative to 1934 Shoreline in blue

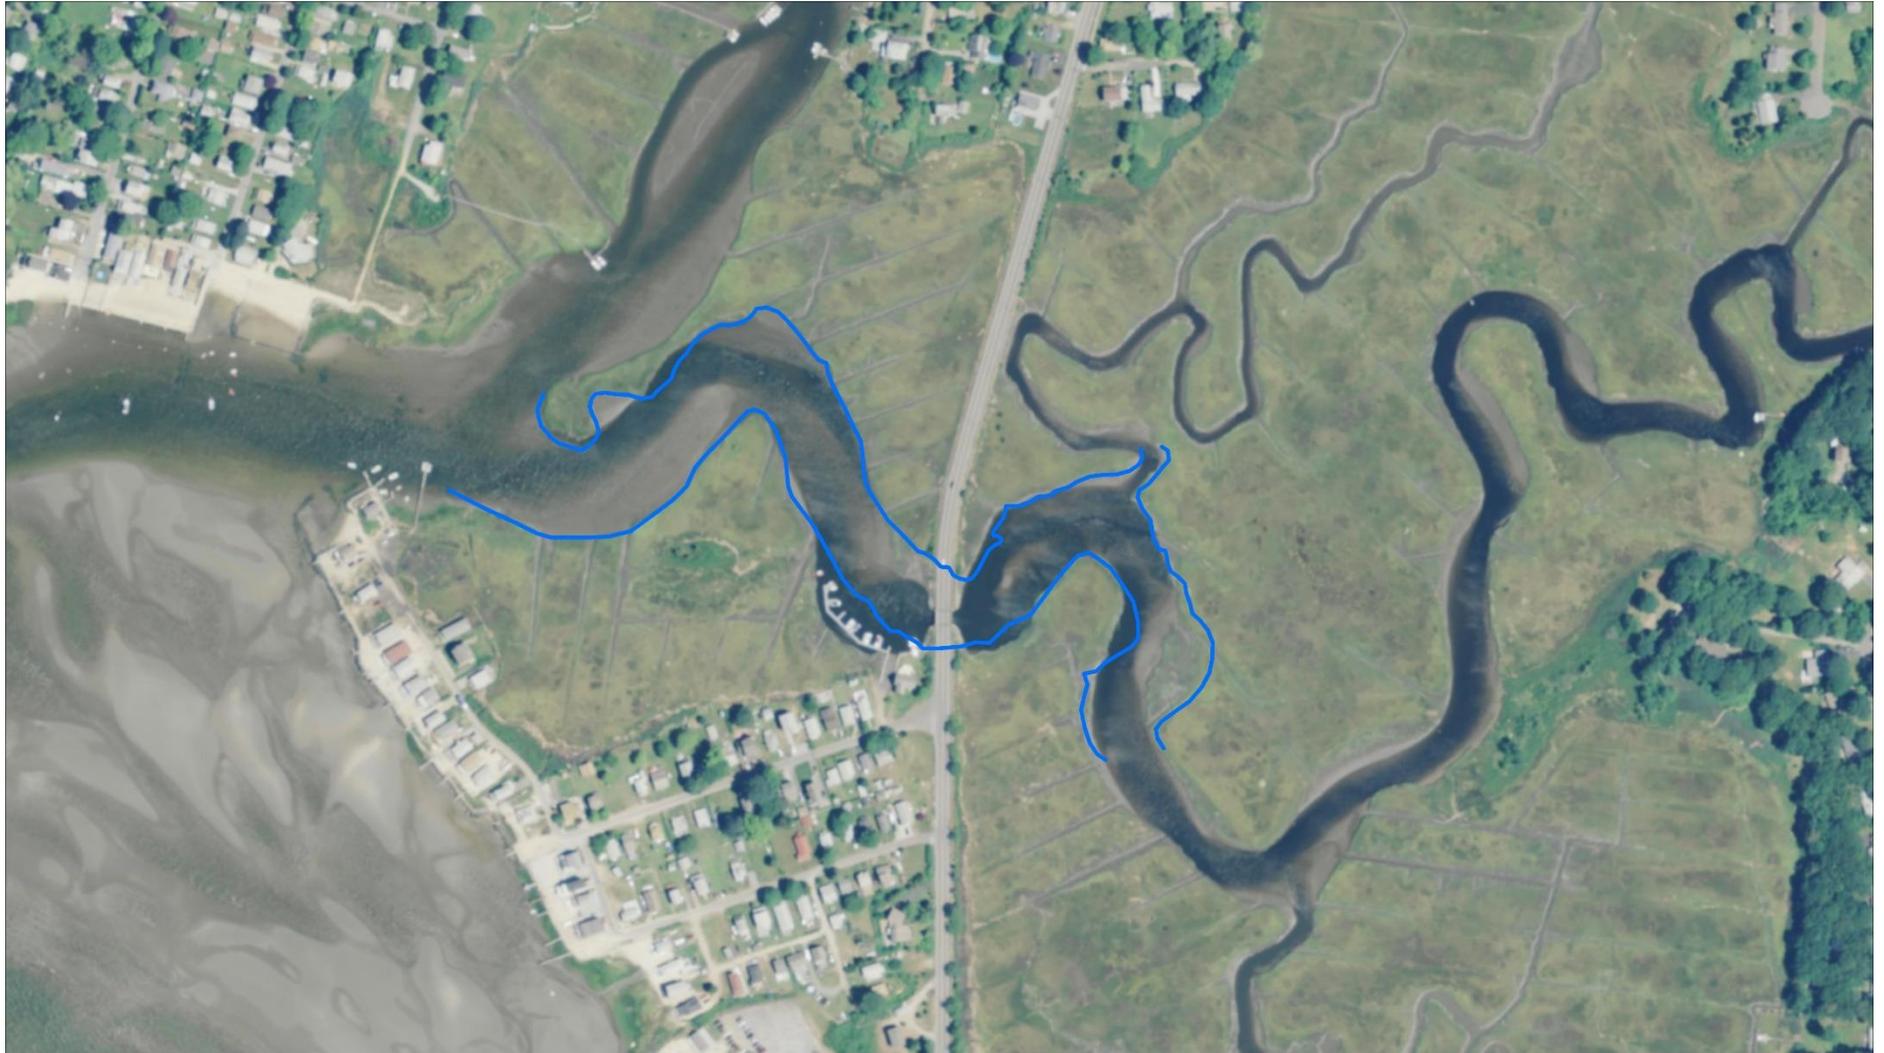
Figure B-6: 2008 Shoreline in Project Vicinity relative to 1934 Shoreline in blue

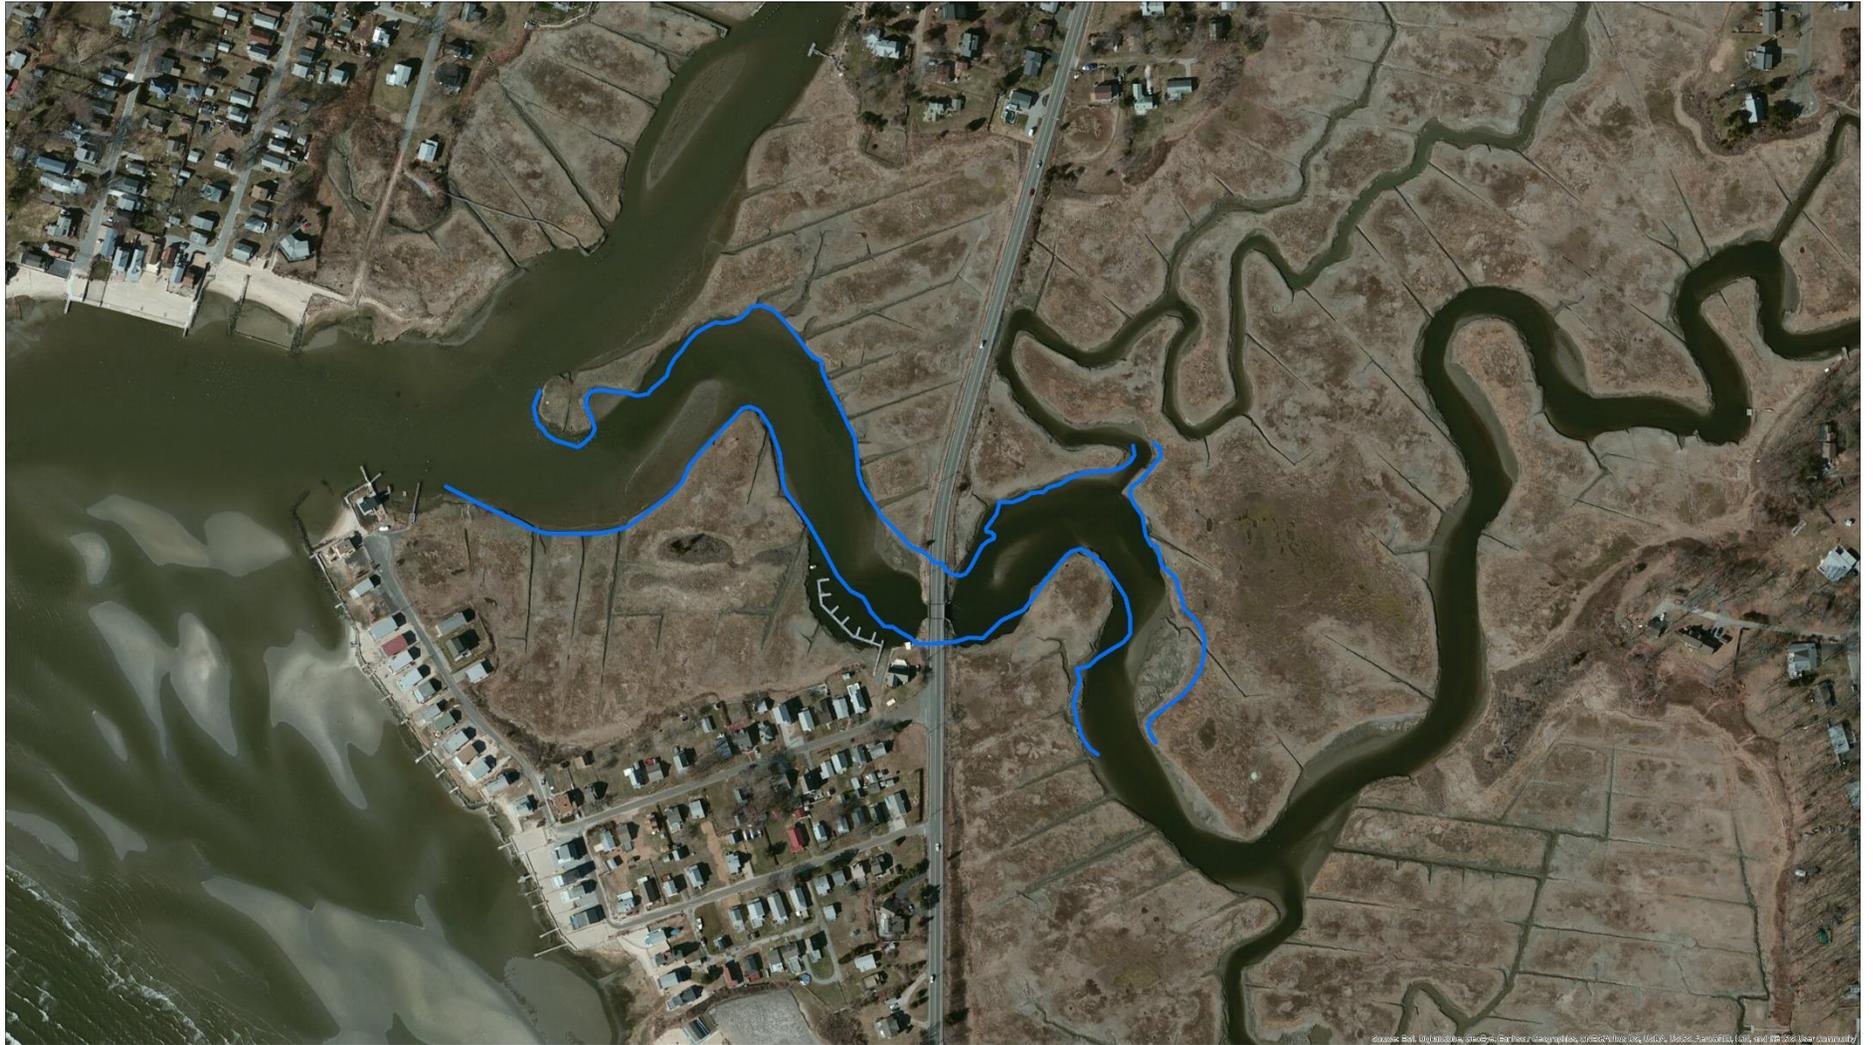
Figure B-7: 2021 Shoreline in Project Vicinity relative to 1934 Shoreline in blue

Based on the available information discussed above, it appears that the marsh and marsh edge is receding due principally to high velocity flow and associated channel bottom and bank stresses resulting, primarily, from the presence of the bridge. These hydraulic conditions have resulted in deep channel scour holes (upstream and downstream) of the bridge. Modelled bank velocities exceed the shear stresses required to result in erosion and scour of marsh and channel sediment, which appears to support the observed shoreline erosion, which since 2000 has been receding at about an average of 1.5 to 1.6 feet per year.

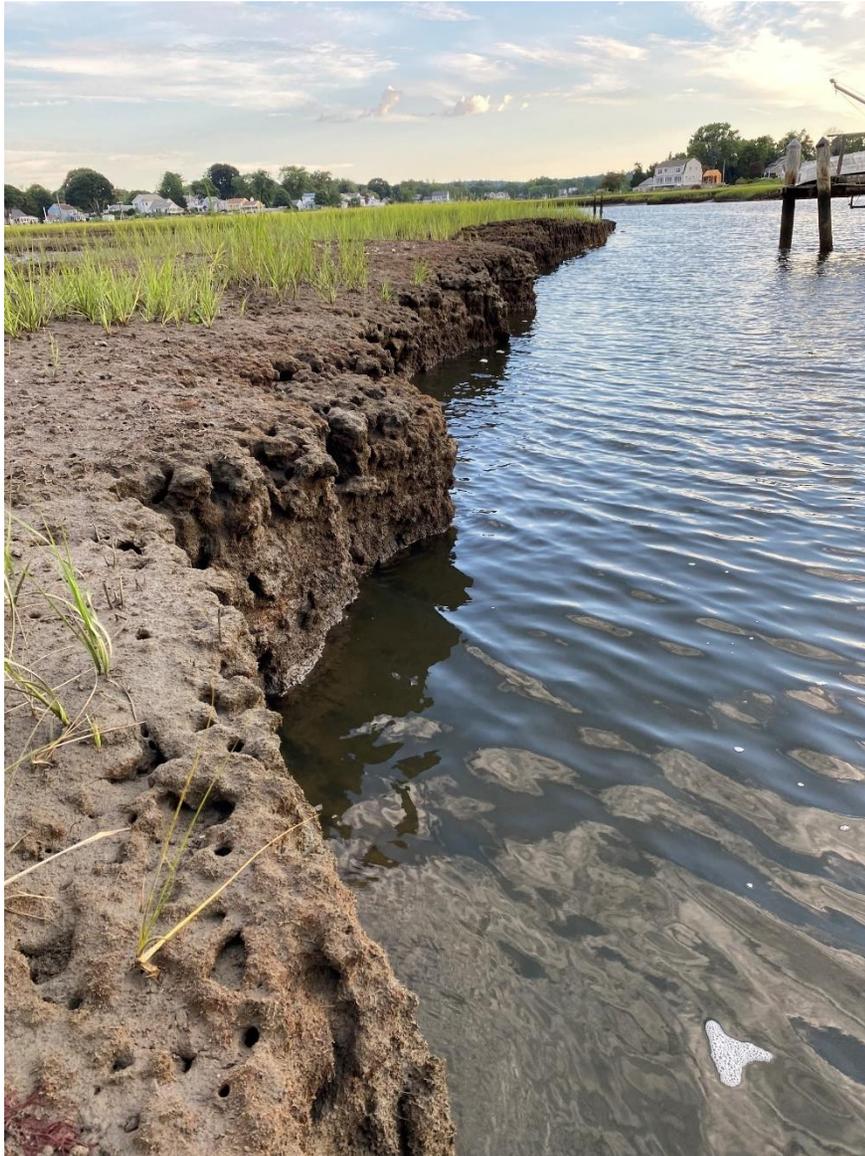
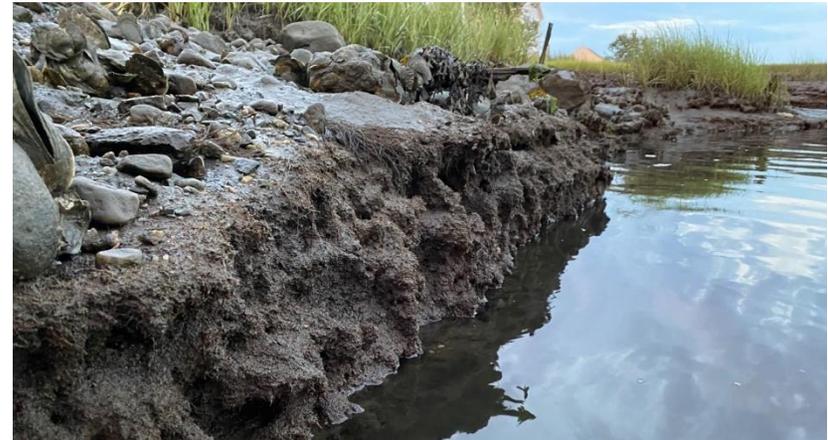
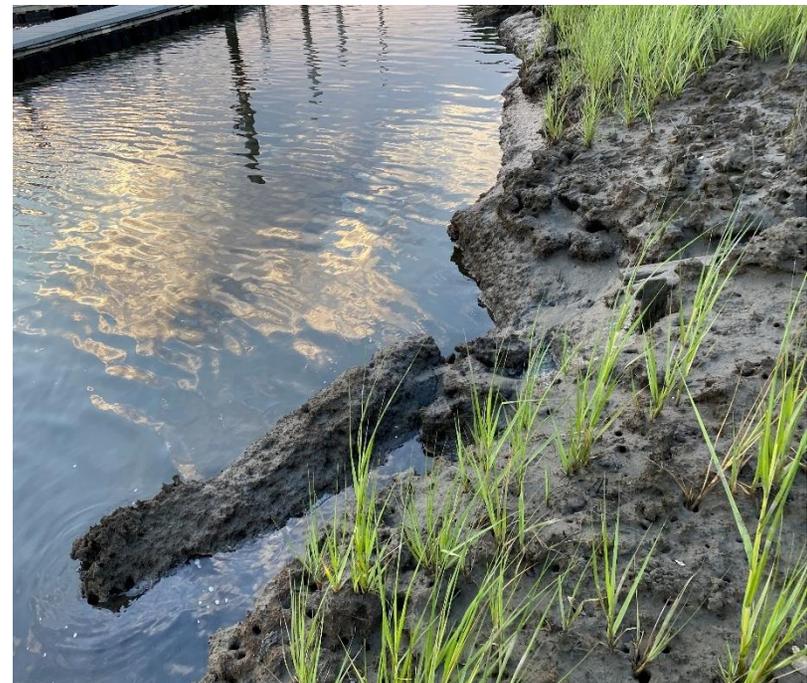
Looking west at the project site during near low tide. Example of sloughing (mass wasting) of marsh edge.

5. The marsh edge consists of a deep (greater than 4 feet) near-vertical face. Evidence of mass bank failure is observable at the site as well as in recent aerial photographs. The submerged bank slope is quite steep seaward of the marsh edge (ranging from 5H:1V or flatter) and appears to be influenced by the deep scour hole within the channel. Gravel, cobbles, and occasional boulders are also located along the bank.

The instigating mechanisms of marsh edge erosion appear to be: 1) surface erosion and scour, resulting in tidal submergence; and 2) edge undercutting resulting in stability edge mass failures (“calving”). As noted above, while we did not directly observe marsh crabs (*Sesarma reticulatum*), there is surface evidence of burrow holes which appear to be consistent with marsh crab activity within the de-vegetated (denuded) areas. If so, it is likely that predation by marsh crabs is also a contributing factor. Specifically, softening of the marsh substrate (e.g., due to erosion and scour) creates a condition conducive to burrowing. Marsh crabs, which predominately eat spartina alterniflora (including root structure), have been linked to marsh de-vegetation and recession. The loss of the marsh vegetation results in oxygenation and weakening of the sediment matrix, facilitating marsh edge erosion and marsh recession.

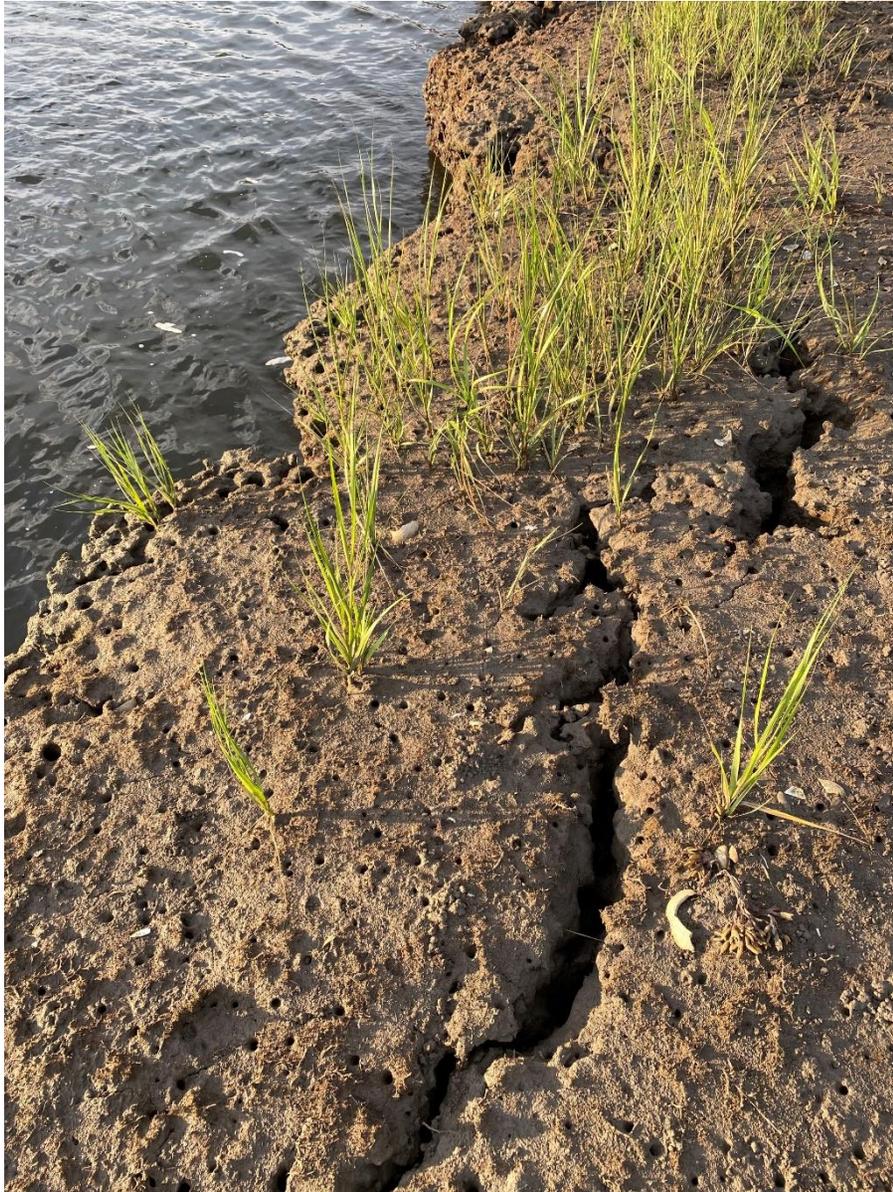
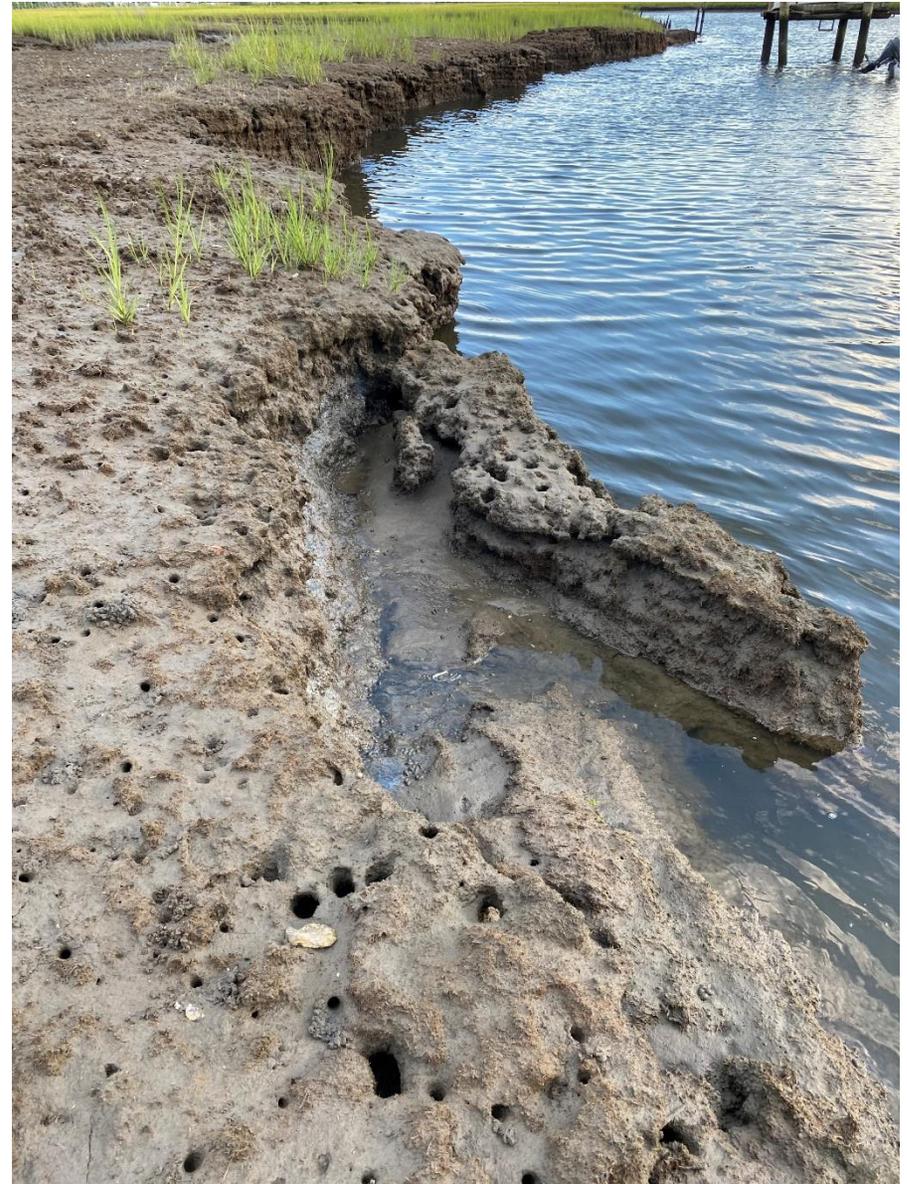
Examples of sloughing (mass wasting) of marsh edge. Clams and mussels present.

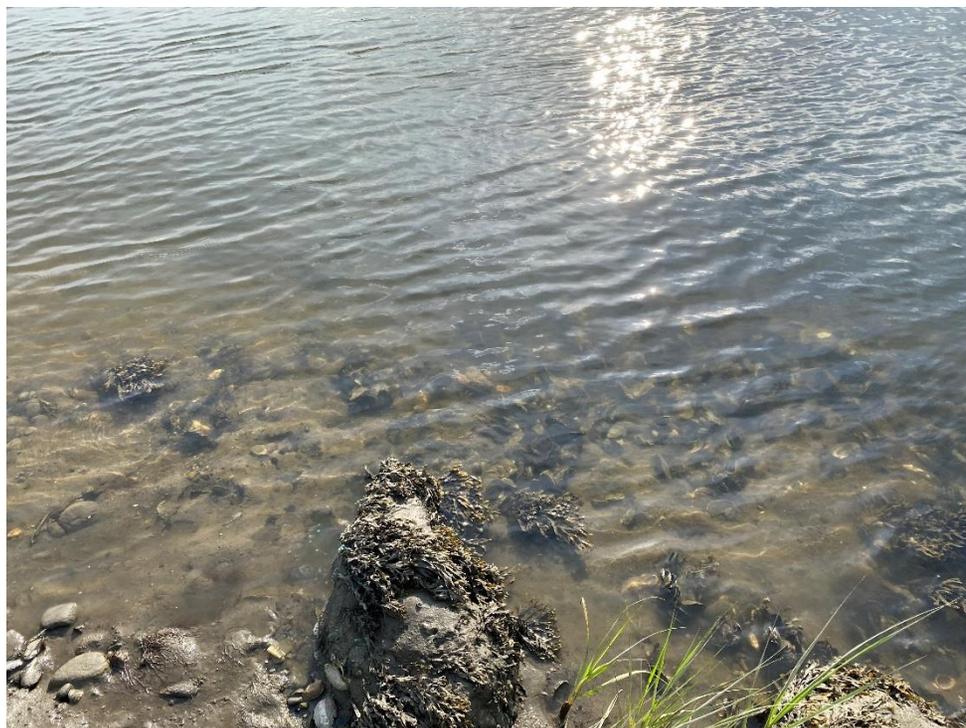
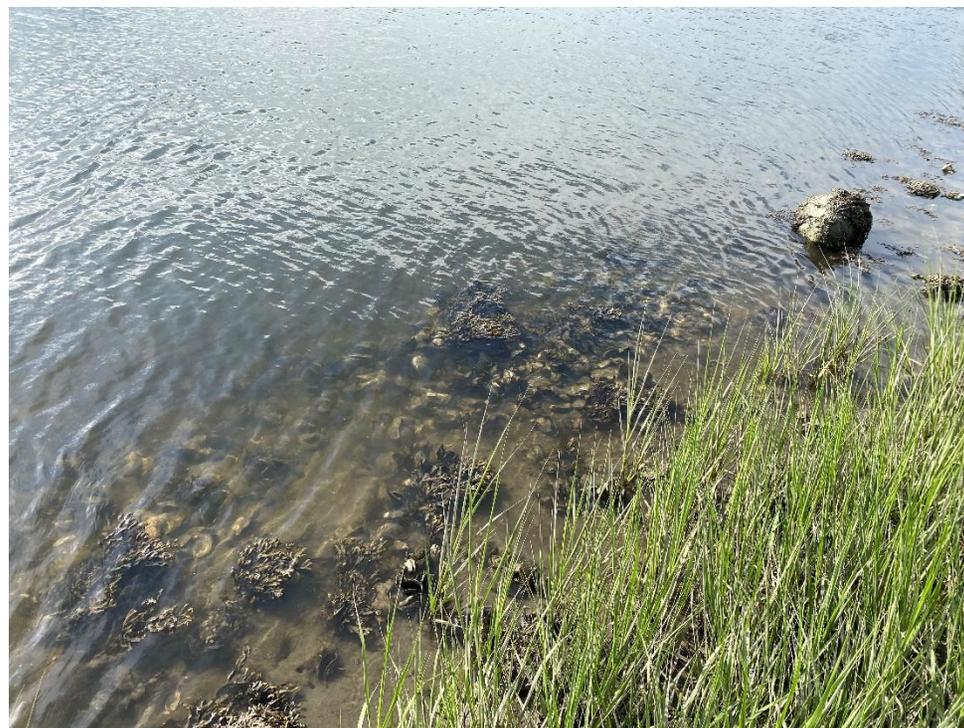
Examples of existing oyster settlement with lower tide and submerged zone.

In the project vicinity, shellfish were observed to be naturally occurring including areas of oyster settlement within the mid to lower tide and submerged and mussels with the upper tide range buried in the mud and attached to marsh grass.

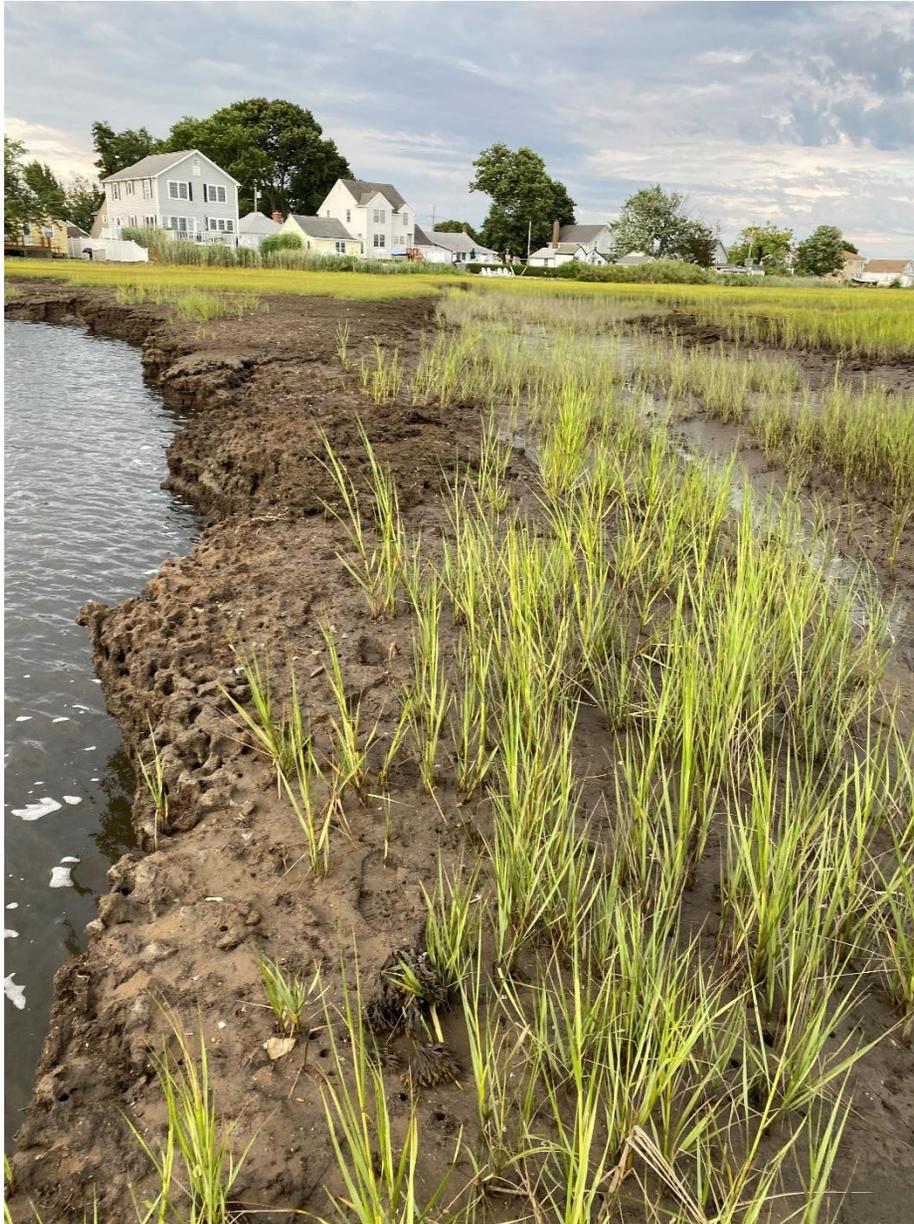
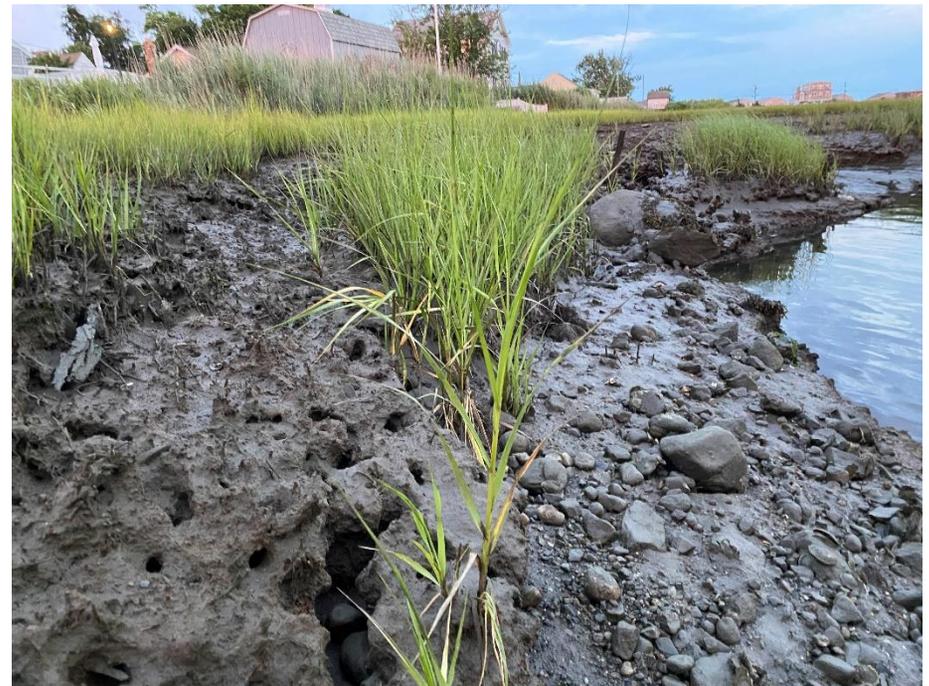
Examples of sloughing (mass wasting) of marsh edge.
Clams and mussels present.
